DEPARTMENT OF TRANSPORTATION

Contract #: 04-0120F4Cty: SF/ALA Rte: 80 PM: 13.2/13.9File #: 69.28**WELDING INSPECTION REPORT****Resident Engineer:**Pursell, Gary**Address:** 333 Burma Road**City:** Oakland, CA 94607**Report No:** WIR-016086**Date Inspected:** 09-Aug-2010**Project Name:** SAS Superstructure**OSM Arrival Time:** 700**Prime Contractor:** American Bridge/Fluor Enterprises, a JV**OSM Departure Time:** 1900**Contractor:** Zhenhua Port Machinery Company, Ltd (ZPMC), Changxing Island **Location:** Shanghai, China

Orthotropic Box Girder (OBG) Trial Assembly Areas

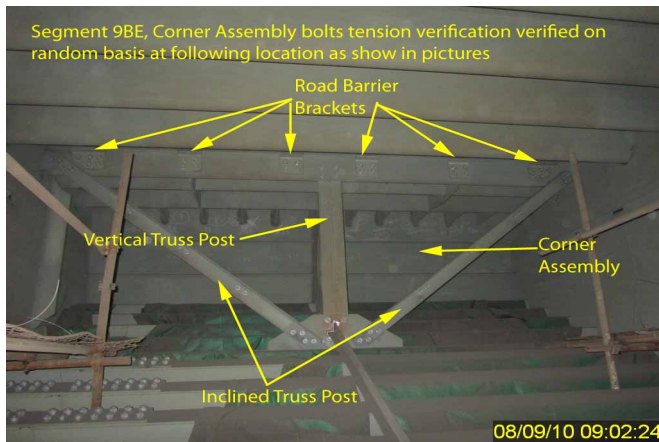
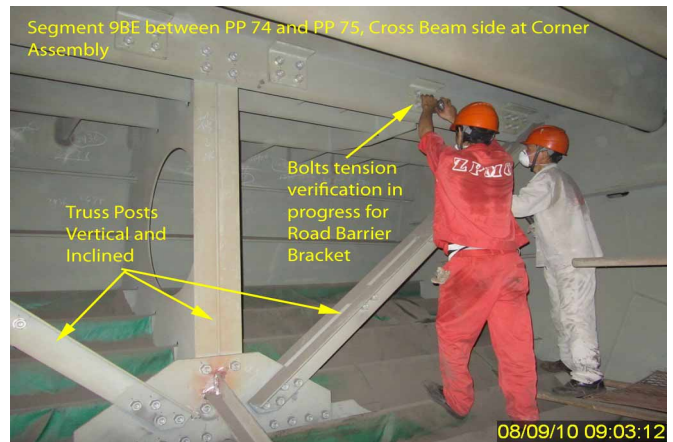
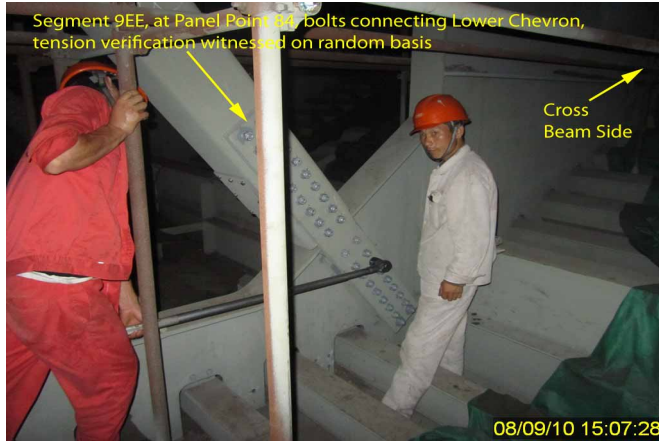
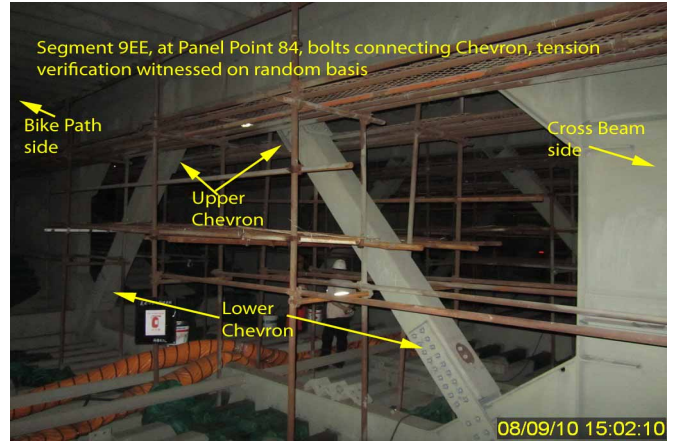
This QA Inspector witnessed the final bolt tension verification on bolts installed at Corner Assembly connecting the Road Barrier Brackets, Inclined Truss Post and Vertical Truss Post at Cross Beam and Bike Path side at Panel Points (PP) 74, PP 75 and PP 76 for Segment 9BE. The QA Inspector verified the bolt tension on a random basis and the results appeared to be in general compliance. The Inspection was performed against Notification No. 00448 dated August 09, 2010.

This Quality Assurance (QA) Inspector witnessed the final bolt tension verification on bolts connecting the Lower Chevron and Upper Chevron at Cross Beam and Bike Path side at Panel Points (PP) 83, PP 84 and PP 85 for Segment 9EE. The QA Inspector verified the bolt tension on a random basis and the results appeared to be in general compliance. The Inspection was performed against Notification No. 00448 dated August 09, 2010.
